St Peter's Parish Church, Powick, Worcestershire, and survey of North Wall of the Chancel.

R.D.Sproat©April 2021.

This is a buildings stonework survey of the north wall of the Chancel at Powick Church. It was originally conducted on behalf of The University of Birmingham as part of a programme of historical buildings recording studies.

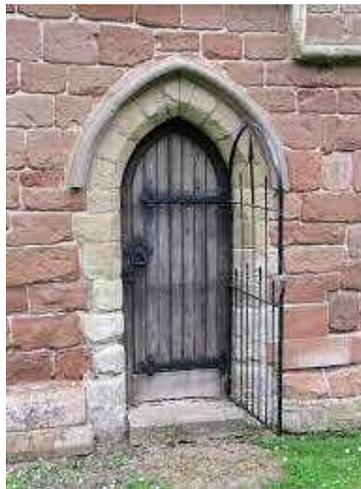
Fig 1. Doorway in North Wall of Chancel.

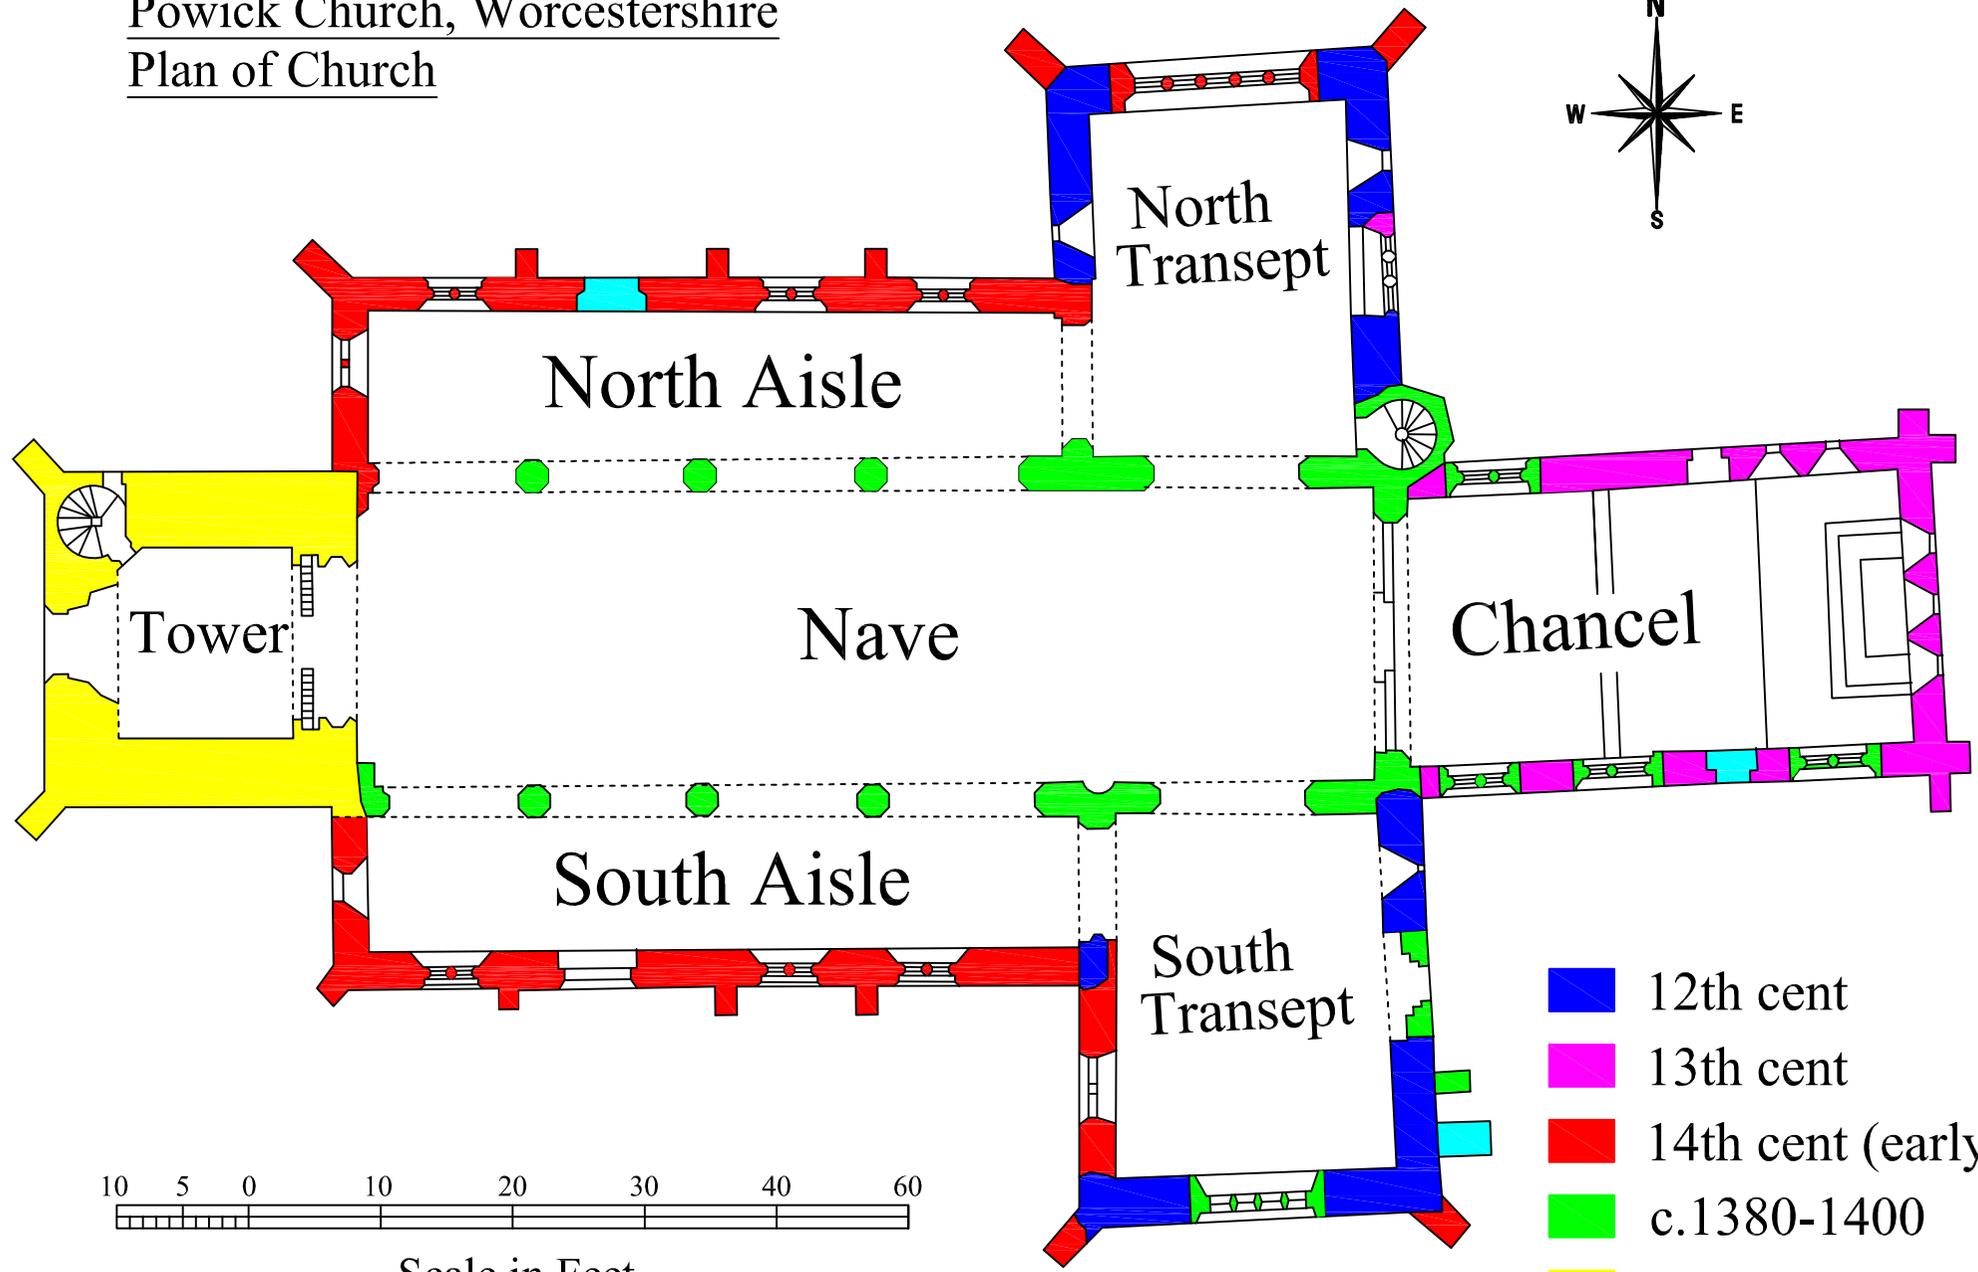
Powick Church, Worcestershire
Plan of Church

- 12th cent
- 13th cent
- 14th cent (early)
- c.1380-1400
- 15th cent
- 16th-19th cent

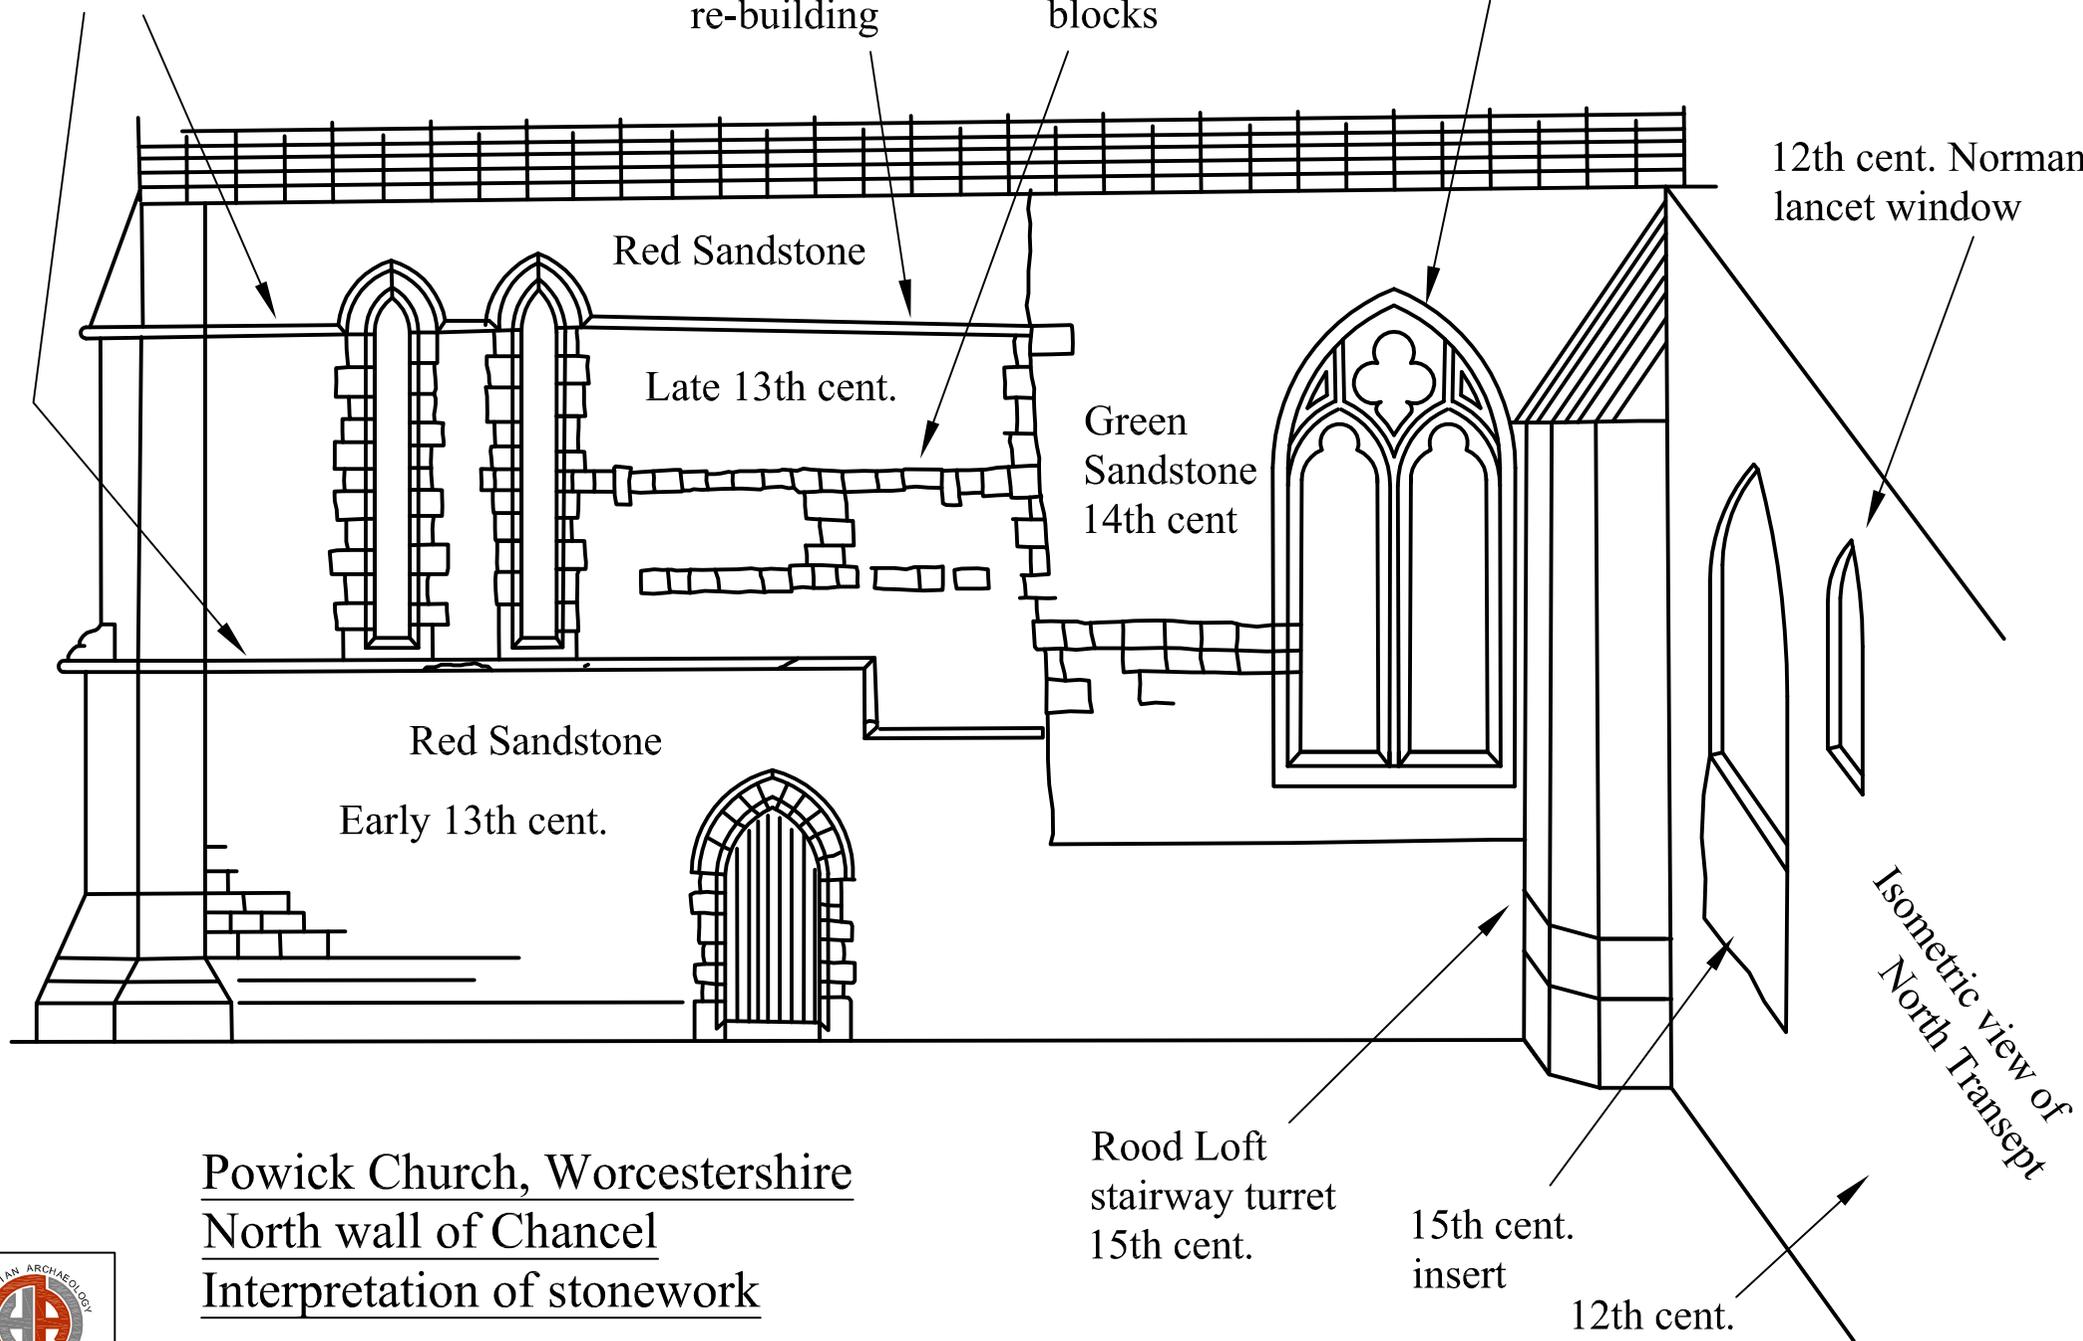
Powick Church, Worcestershire
North wall of Chancel
Interpretation of stonework

Roll moulding encompassing Chancel before re-building

Roll moulding sunk during re-building

Green Sandstone blocks

Later window insertion, and wall, (where roll moulding Stops)

Red Sandstone

Late 13th cent.

Green Sandstone 14th cent

12th cent. Norman lancet window

Early 13th cent.

Isometric view of North Transept

Rood Loft stairway turret 15th cent.

15th cent. insert

12th cent.

The Chancel was probably re-built and lengthened in the 13th century to replace an original smaller 12th century chancel. It is built in roughly coursed pink/red sandstone. Later in the 13th century the upper section of the chancel was rebuilt to include the two gothic lancet windows seen today. The roll mouldings probably went all round the chancel but were stopped on the north side by the insertion of the later window.

In the 14th century a section of the north chancel wall was removed and a new part of the wall inserted, constructed of green sandstone together with a finely traced window insert. This may have been accompanied by some re-building of the adjacent wall as the roll moulding mentioned above appears to have sunk down over time.
